Product Reliability Qualification Strategy & Report PPAP

Quad source TJA1028TK/5V0/10, TJA1028TK/5V0/20, TJA1042TK/3, TJA1049TK, TJA1049TK/3, TJA1051TK/3

4.0 — June 27, 2023

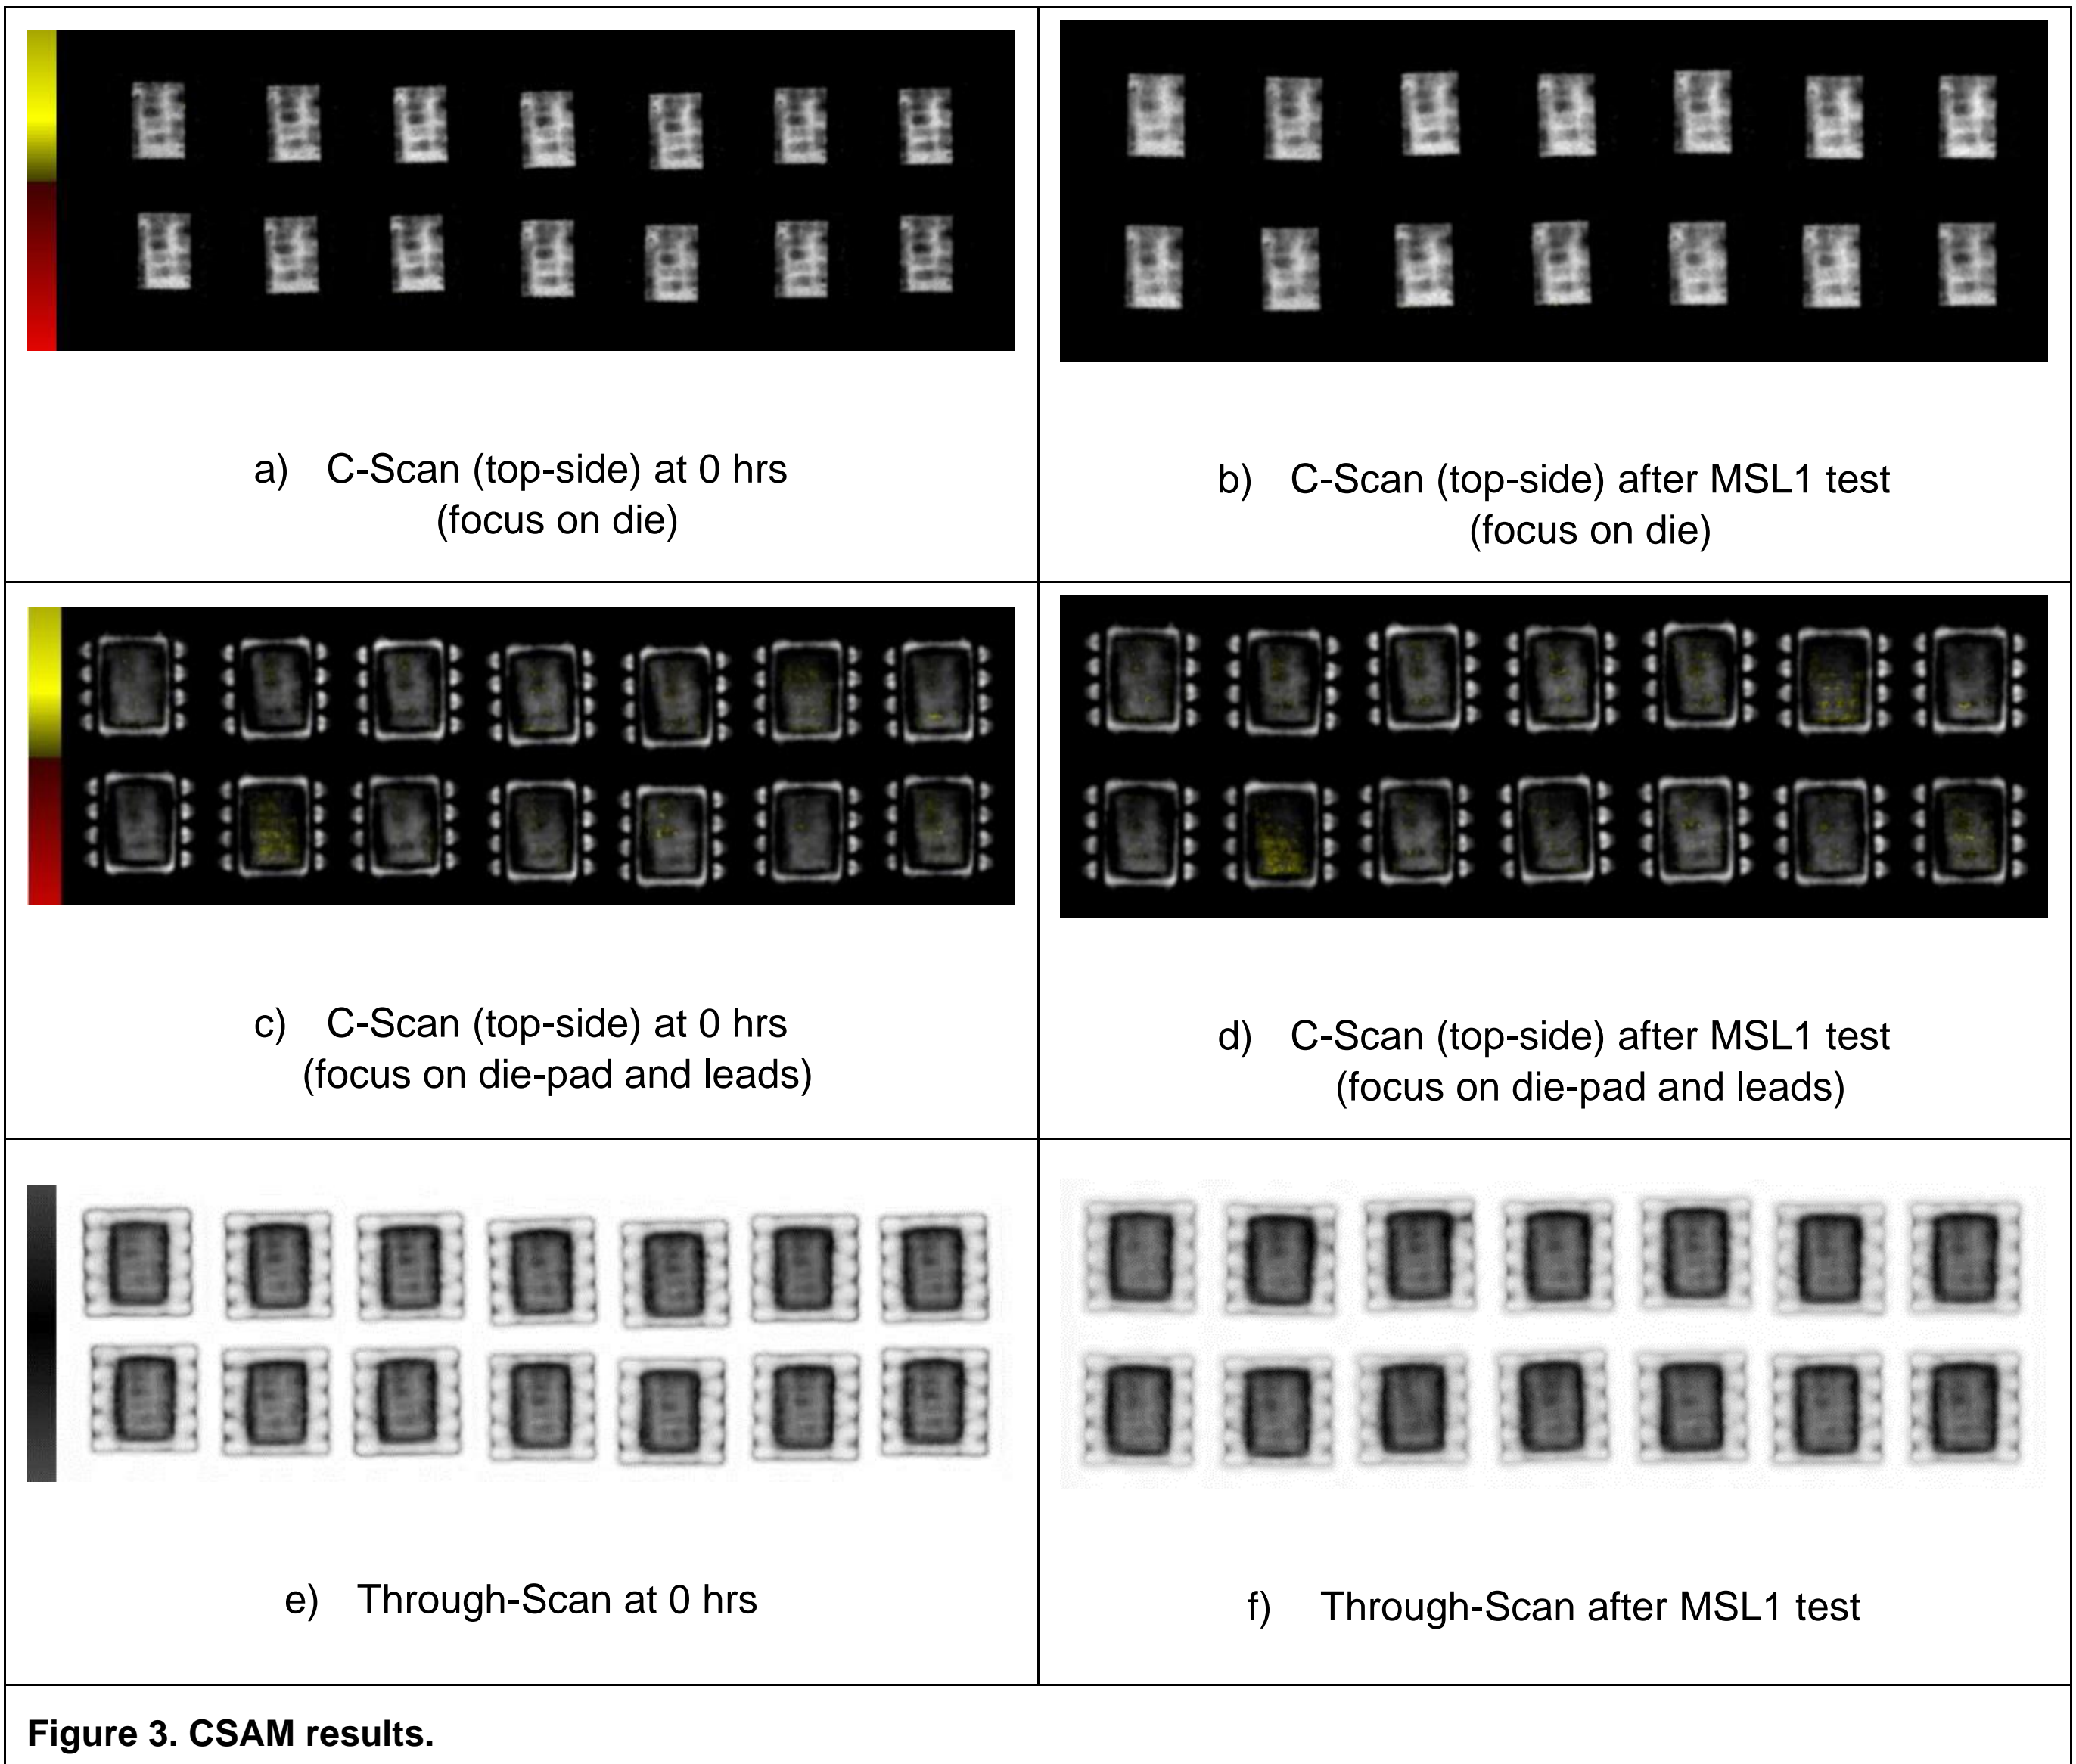
Figure 3. CSAM results.

The images shown in Figure 3 show the CSAM results of lot 1 that have been collected during moisture sensitivity level assessment (MSLA). No delamination was observed, neither at 0 hrs nor after MSL1 test. The images refer to lot 1 manufactured in SSMC and assembled in ASEN, but are also representative for other analyzed lots, including those manufactured in ICN8 and/or assembled in ATBK.

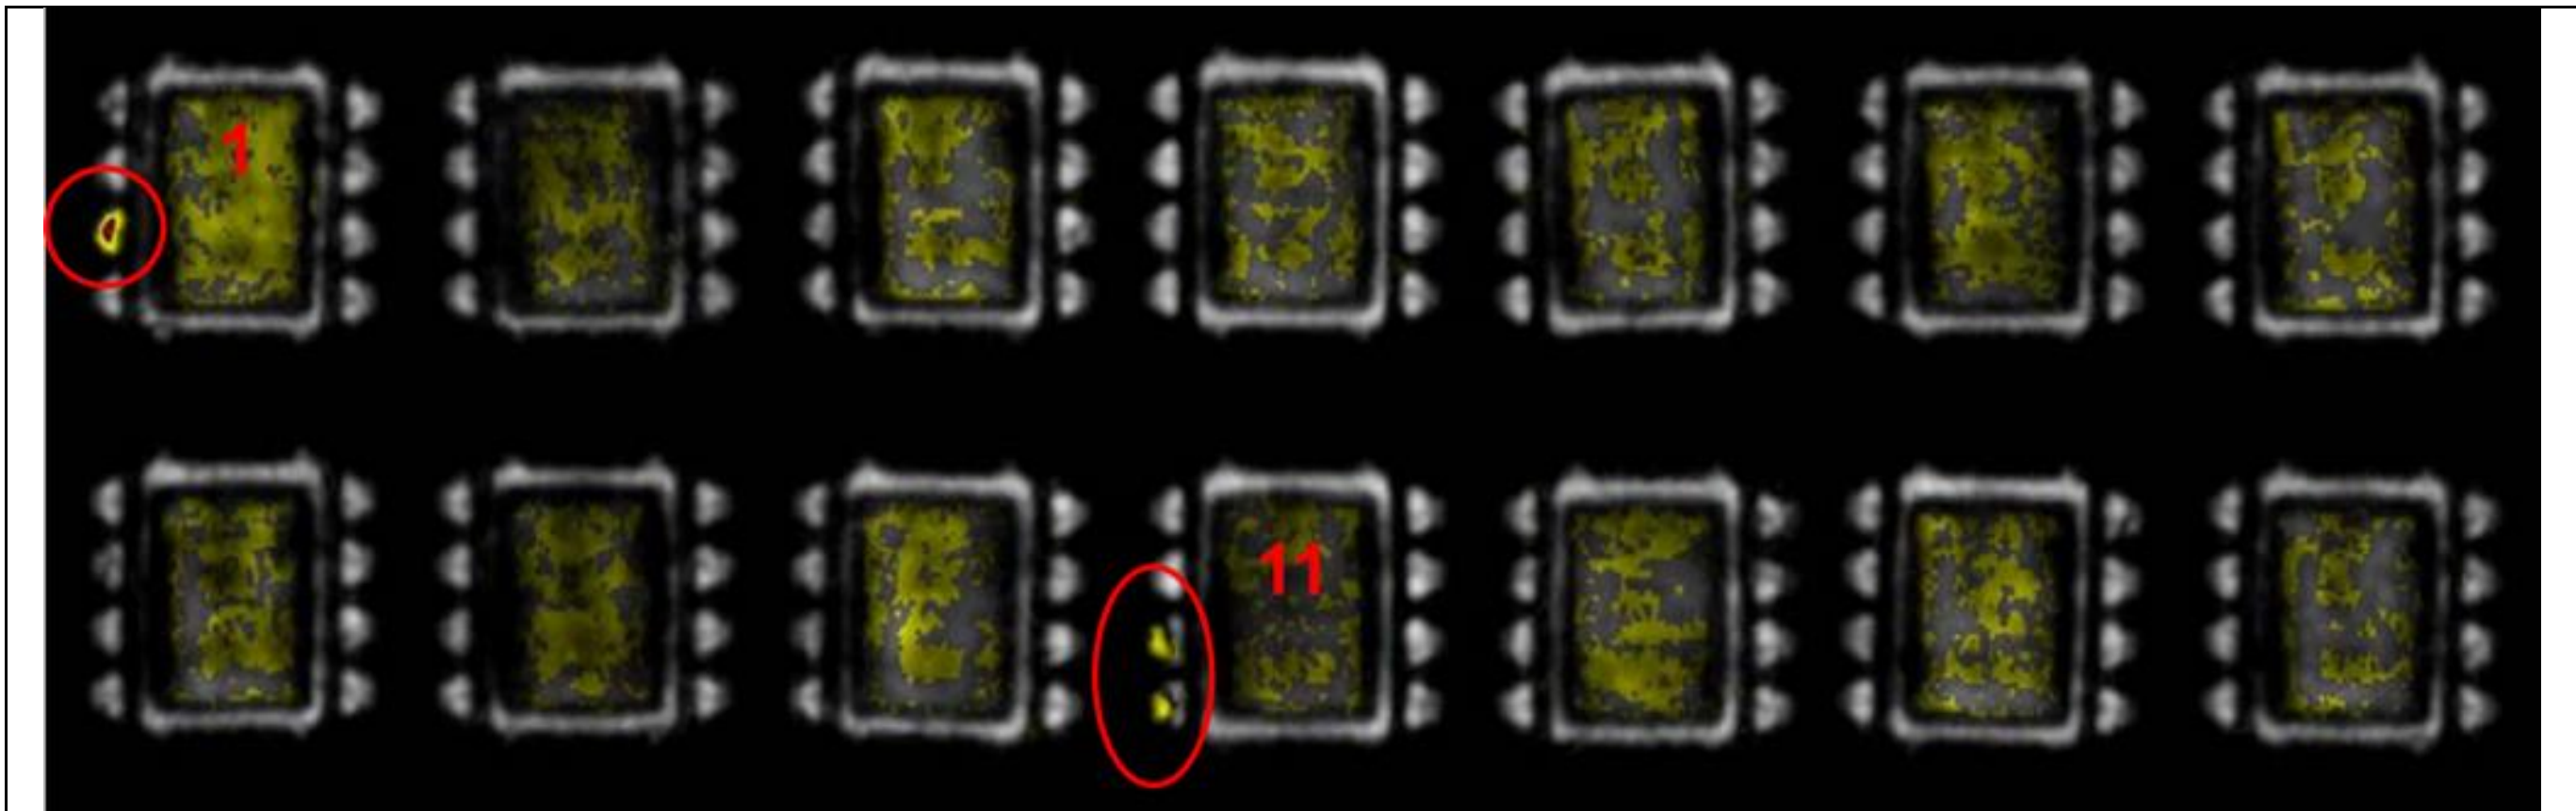
Figure 4. Lead delamination observed after PCON before HAST for lot 5.

After pre-conditioning before HAST of lot 5, CSAM analysis showed lead delamination on 2 samples out of 14, see Table 3. No delamination was observed on lots 1 and 3. Also, no delamination was found after PCON for lot 5 samples for TC. Visual inspection showed plating peel-off on the leads. During an 8D investigation, the lead delamination was not observed on other samples, even not after PreCon was performed on 77 samples of both the affected lot and a control lot. Checks of the process mapping and process variation did not show any abnormalities. The plating peel-off was discussed with the lead-frame supplier, but that did not reveal any abnormalities or give an indication of the root cause. Also other investigations did not reveal a potential root cause. As corrective actions, the following measures have been defined:

After PCON of lot 5, lead delamination was observed, see Figure 4. This issue is discussed in section 2.3.2.

- The sample size for the plating peel-off test at incoming inspection was increased for the first 20 batches. No plating peel-off was observed.
- 100% automated optical inspection (AOI) was installed for the first 10 assembled production lots. No abnormalities were observed.
- CSAM analysis was performed for the first 10 assembled production lots, to check for lead delamination. No delamination was observed.
- PCON followed by CSAM analysis was performed for the first 10 assembled production lots. No delamination was observed, neither at 0 hrs nor after PCON.

The results from these measures all passed the criteria. Therefore, the lead delamination, observed on only two devices during qualification, was a one-time incident.

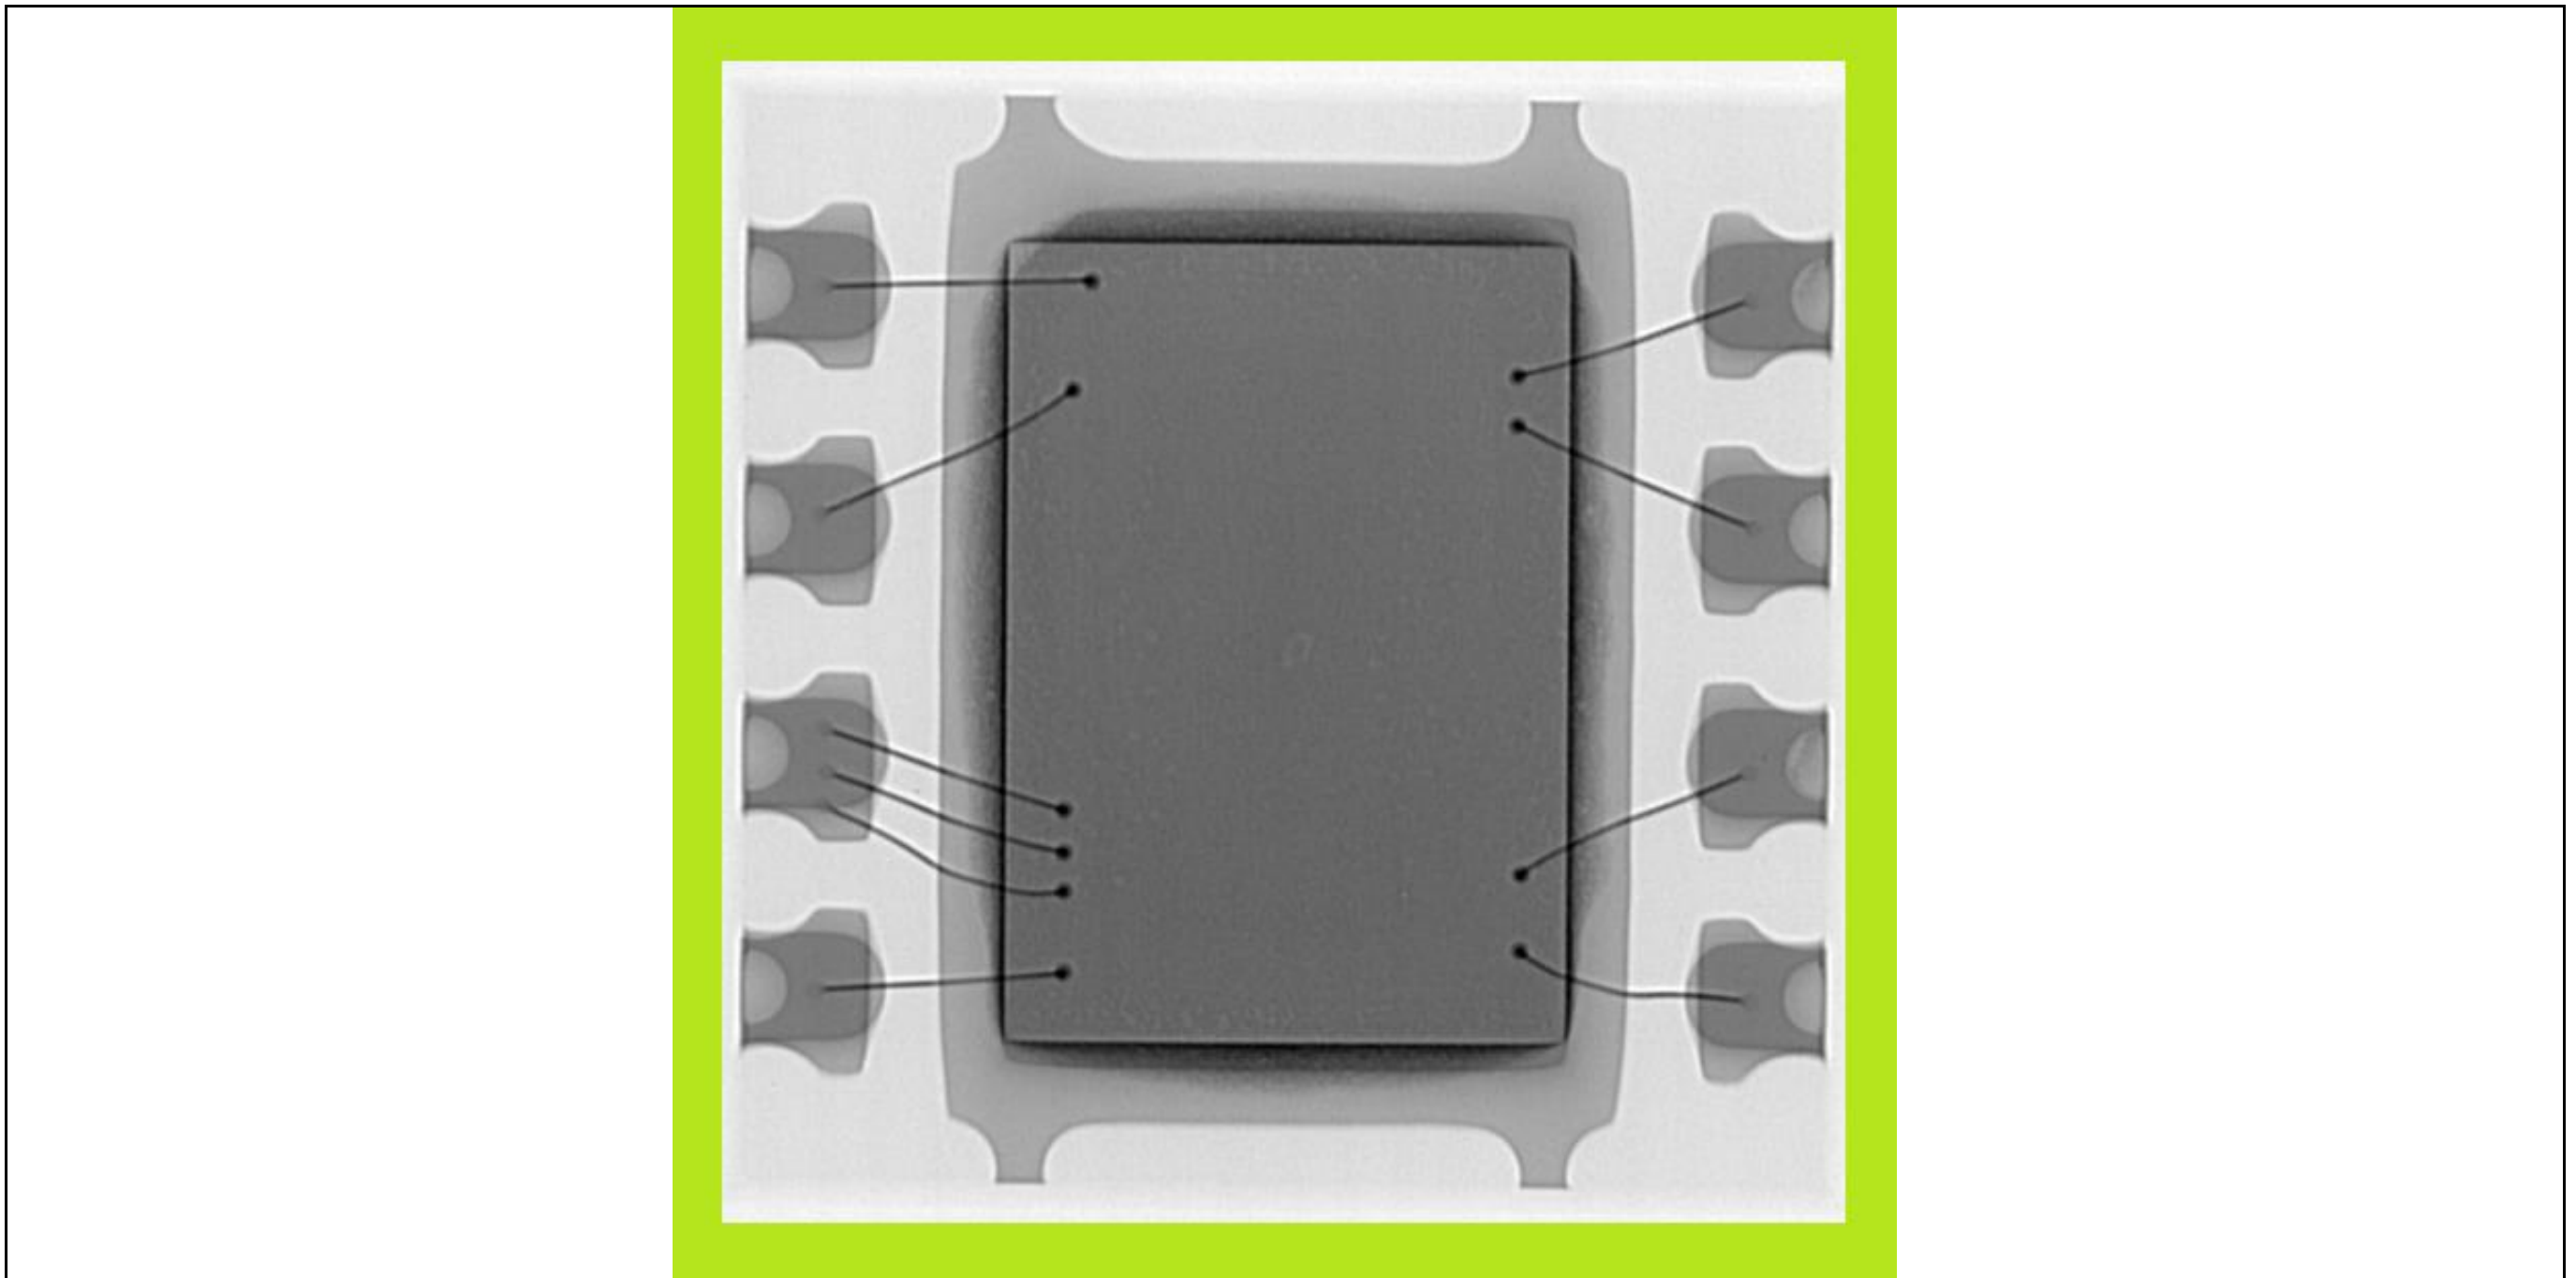
Figure 5. X-ray photo.

Figure 5 shows an X-ray image of a qualification sample, illustrating lead-frame design, internal package structure, and wiring. The images refer to lot 1 manufactured in SSMC and assembled in ASEN, but are also representative for other analyzed lots, including those manufactured in ICN8 and/or assembled in ATBK.
