Chip Errata for the i.MX 6Solo/6DualLite

This document details the silicon errata known at the time of publication for the i.MX 6Solo/6DualLite multimedia applications processors.

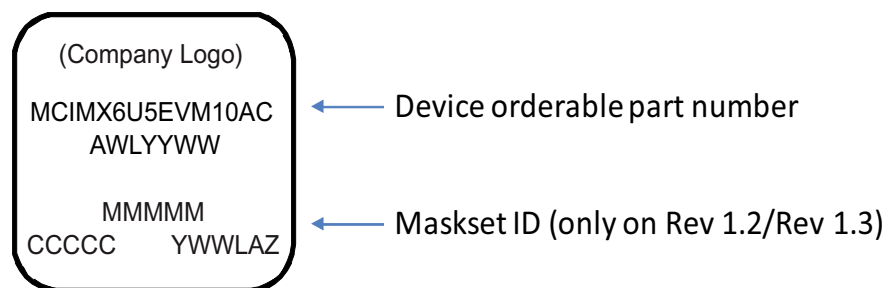
Figure 2. Example Part Marking for Revision 1.2/1.3 Devices

Figure 2 shows an example part marking for Revision 1.2/1.3 devices.
